THERMAL MONITORING LADLE FURNACE *

From time-to-time ladle breakouts may occur, typically in the slag-zone. To prevent a ladle breakout, four infrared (IR) thermal cameras were installed in the ladle furnace station to prevent ladle refractory brick failure, thereby reducing maintenance costs and increasing operation safety. The system analyzes the temperature profile of the ladle shell during heating and is connected to the furnace's programmable logic controller (PLC) and Inteco smart electrode controller (ISEC), its electrode regulation system. In the event of hot spot detection, the furnace automatically stops the heating and signals an alarm to the operator via the furnace PLC and human machine interface (HMI). Additionally, a four-screen monitor was installed, allowing the operator to monitor the temperature profile of the ladle furnace at any time.

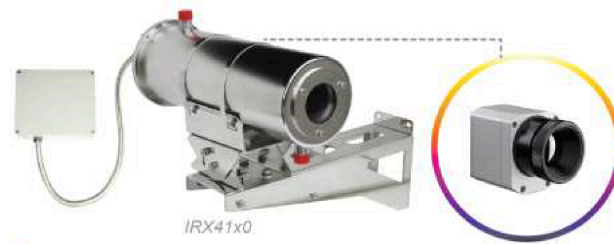
Figure 3. Thermal imaging camera including housing.

The concept of covering the entire surface of the ladle shell requires the installation of four thermal cameras. Each camera must be protected with a water-cooled housing and allows for an operating temperature up to 200 °C. The pressurized compressed air system ensures clean lenses and provides additional cooling.

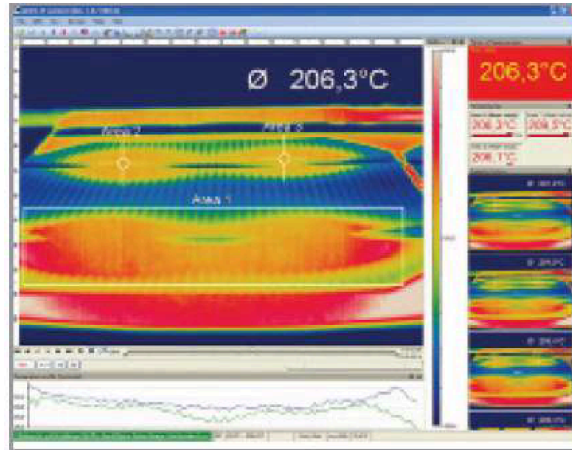
The IR-Scan-Software manages the communication between infrared cameras and the remote I/O module. It allows for the management of up to 16 analogue outputs or 16 digital input/outputs to be associated with up to four thermal imaging cameras. It also allows individual cameras to generate streaming video in various formats, management of up to four maps, and temperature trend graph monitoring.

Figure 5. IR-Scan-Software.

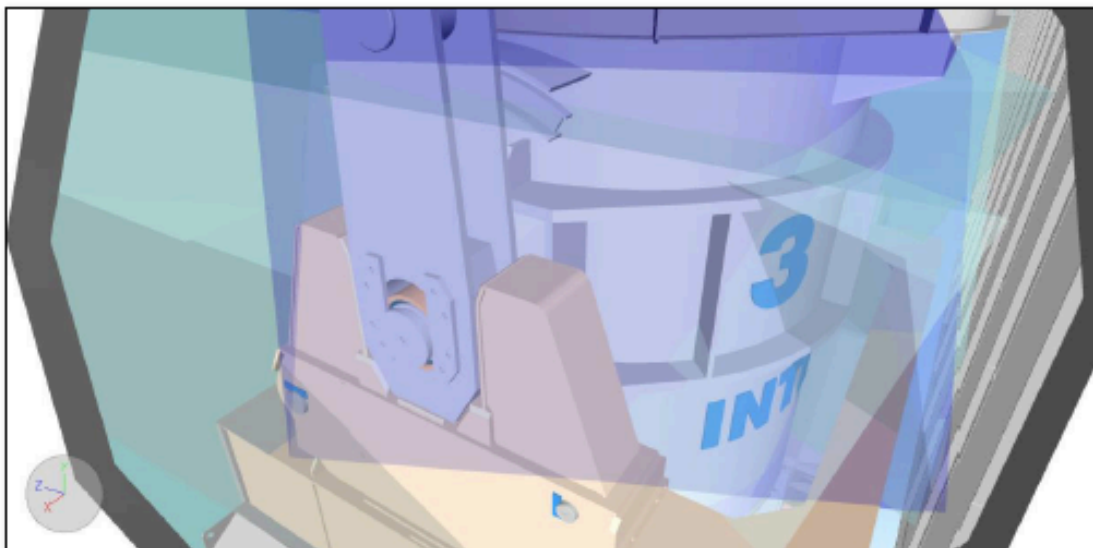
Figure 8. Area coverage (trunnion side - detail).

The positioning and angulation of the four cameras are depicted in figures 6, 7 and 8.

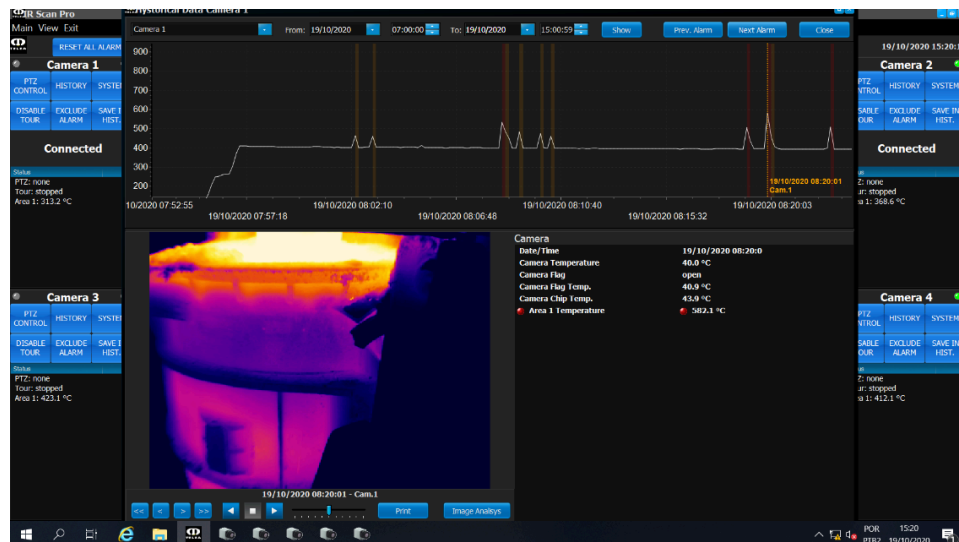
Figure 14. Historical data of the temperature profile.

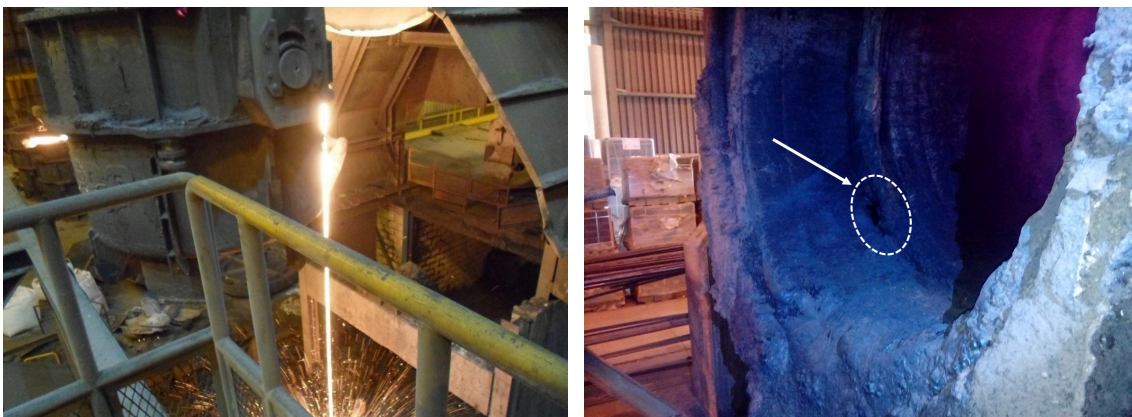
Figure 14. Example of ladle breakout.

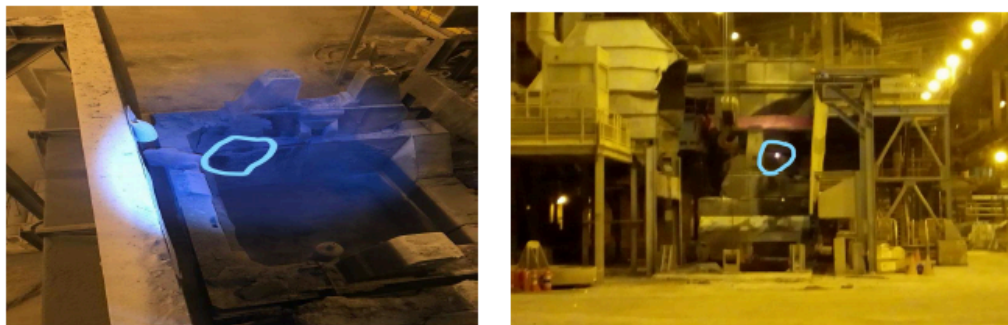
Figure 15. Example of ladle breakout and equipment damage.

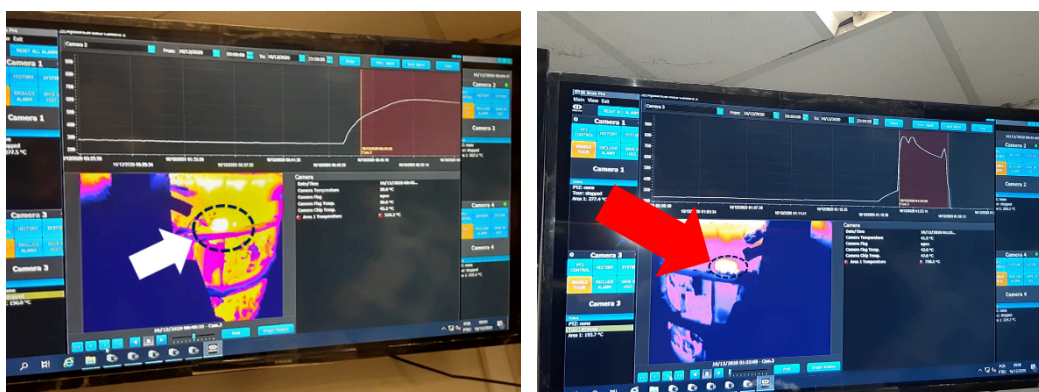
A few days after the thermal monitoring installation was complete, the system caught an incident due to refractory lining wear.

Figure 16. Hot spot on ladle shell during operation.

Upon becoming aware, the operator took immediate action to remove the ladle based on information from the thermal camera (hot spot) and PLC (HMI) system.

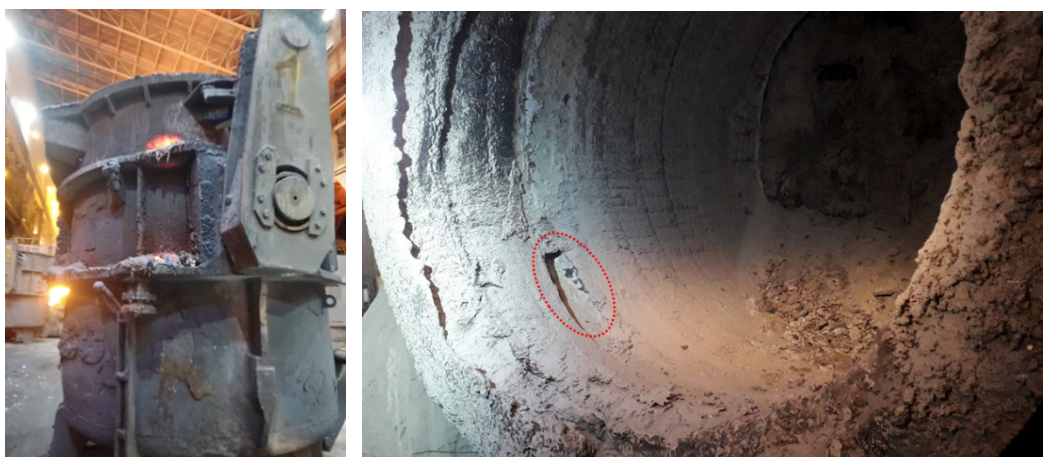
Figure 17. Refractory wear that caused hot spot on ladle shell during operation.
